CALSPAN ON-SITE AIR BAG DEPLOYMENT INVESTIGATION

CALSPAN CASE NO. 91-14

FLEET - 1992 PLYMOUTH ACCLAIM

ACCIDENT DATE - [REDACTED] 1991

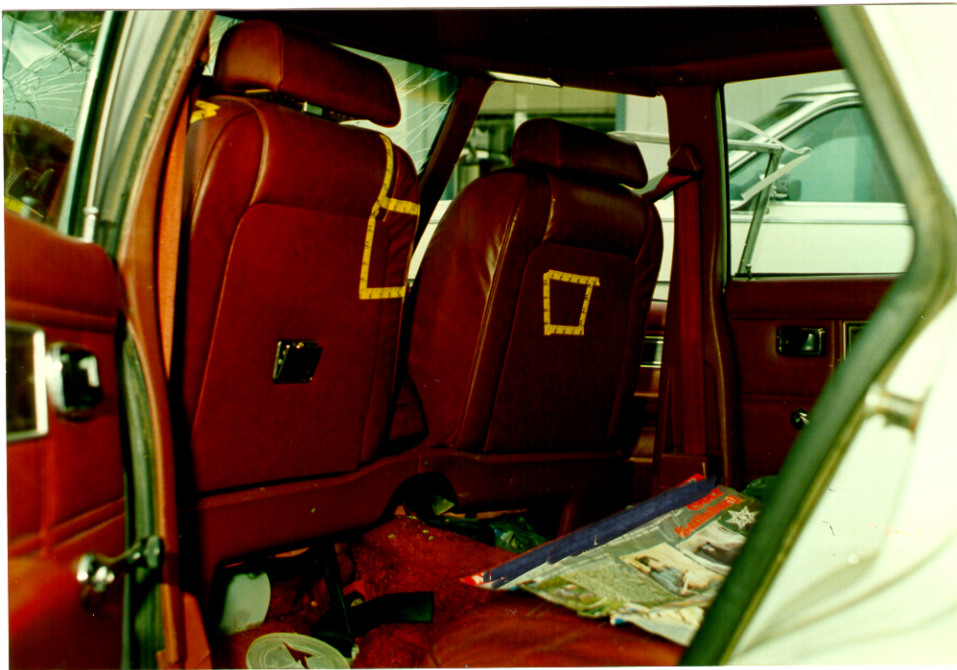
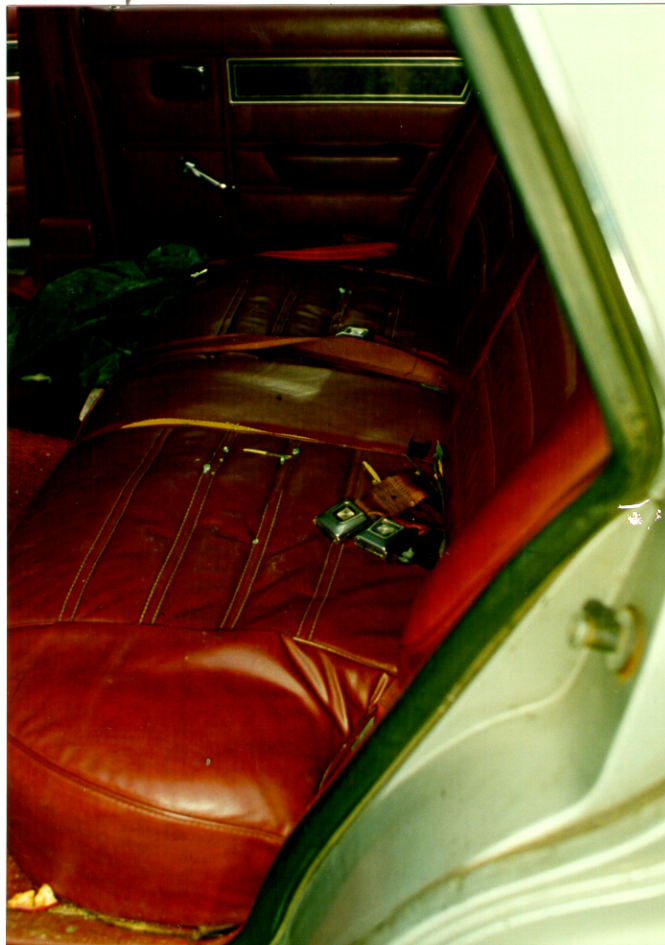
Rear Seat Views Of The Front Seatbacks And Lap Belt Systems.
